## 1986 S10 Extended Cab Rear Side Glass Conversion from Fixed to Moveable.

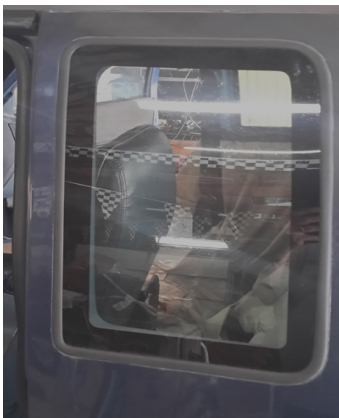
Shown is a typical S10 Fixed Side Glass from 1982-1993. Urethane sealant was used to bond the glass assembly into place.

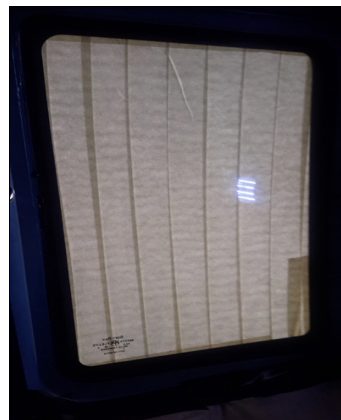
Even though the picture is dark or the surrounding window area, you can see the tape on the outside covering the glass. Hopefully this will be all that is needed. I have covered the interior area below the glass to catch any debris falling into the cab during the removal.

When working with glass of this type, it can explode when stressed or damaged. I therefore decided to protect myself by covering the exterior of the glass with masking tape to control any such happening where glass might be flying around. A simple step to make sure your eyes are protected and you do not have a big mess.

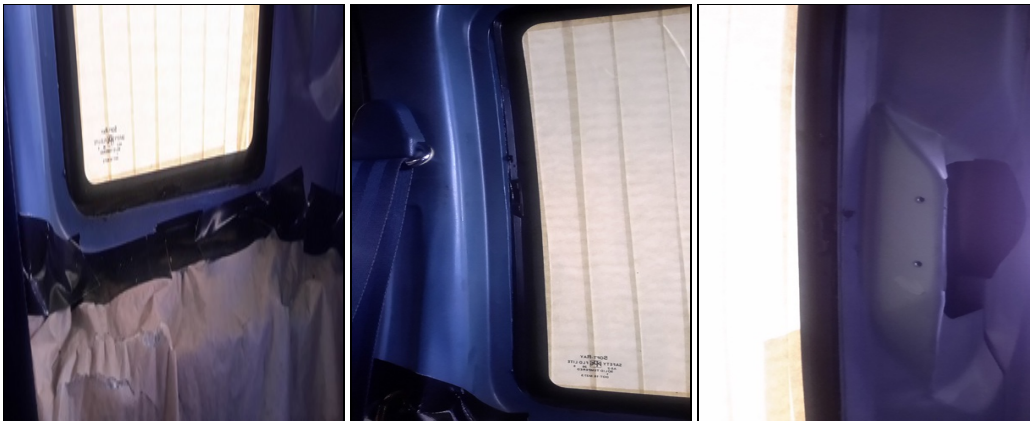
Noted: The front Inner Frame area shows no holes for securing the metal hinges, in the left picture. While the right pictures shows only 2 of the 4 holes required to secure the rear latch assembly.

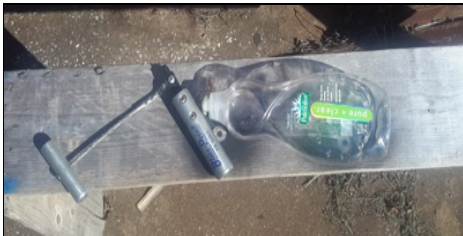
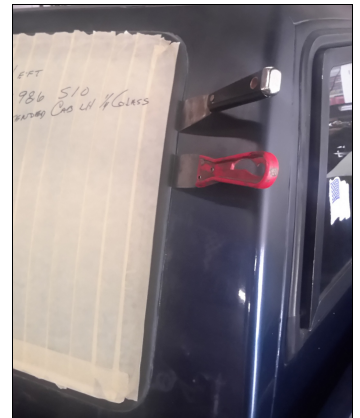
These are the main tools used to cut the glass free. A hand glass cutter and some dishwashing soap. The soap was a good lubricant to keep the knife from dragging and sticking. After many trips around the glass, the glass was still tightly affixed so additional tools were used. I used two thin bladed putty knives to slide under the outside weather seal to body area around the glass and gently lift the glass. The urethane was holding tight to the frame and the putty knives slowly started to cut the urethane from around the window frame.

Cutting of the urethane is done by inserting the blade of the glass cutting tool into the urethane closest to the metal body and pulling the tool in a straight line along the edge with one hand while holding the tool perpendicular to the opening with the other hand. The use of putty knives did cause paint damage as they where moved around the window opening. There should be a better way. Each truck will be a little different, I would imagine, as to the placement and amount of urethane applied at the factory.

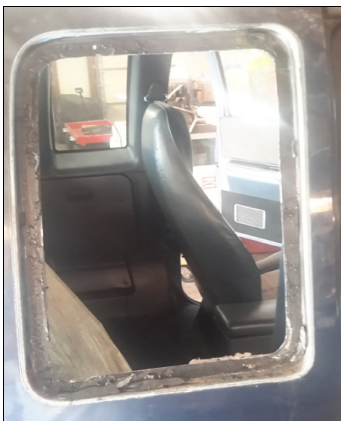
"Cab Window opening - Urethane"

### Three Views of the urethane left on the window frame and glass after it was cut loose.

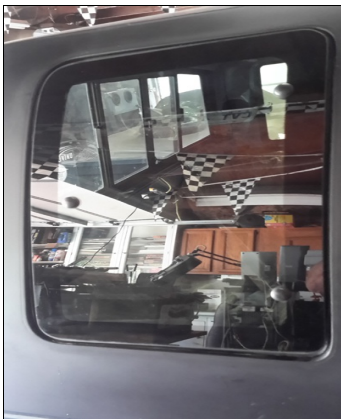
Installed weather seals

These are the Buttons as shown with the hinges. They are the outer button that is the retaining nut, The glass seal cushion that touches the outside of the glass, the inner seal cushion that touches the inside of the glass, the Hinge, The inner retaining spacer and locator which holds the screw and lastly the screw that when tightened secures all pieces together. The latch system is the same except the receiver is part of the latch mechanism.

With the latch assembly affixed to the glass window the 4 screws that hold the Latch to the body were secured in place. Then the Buttons were positioned to the glass and hinges with their screws to locate and secure the glass window.

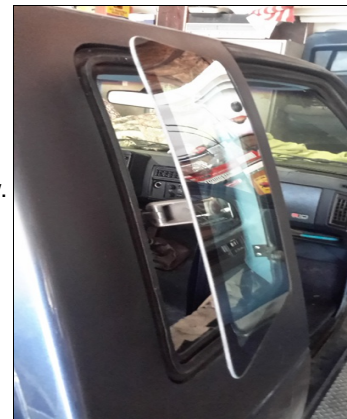
Installed weather seals

We have both views with the glass closed in the picture on the left and the glass opened in the picture on the right. Hopefully these pictures will show just how the changing of the windows will help the air flow through the cab.
